Final

**PHASE I ENVIRONMENTAL BASELINE SURVEY
PARCELS E2, F, and I, MILITARY HOUSING AREAS
NELLIS AIR FORCE BASE, NEVADA**

September 2011

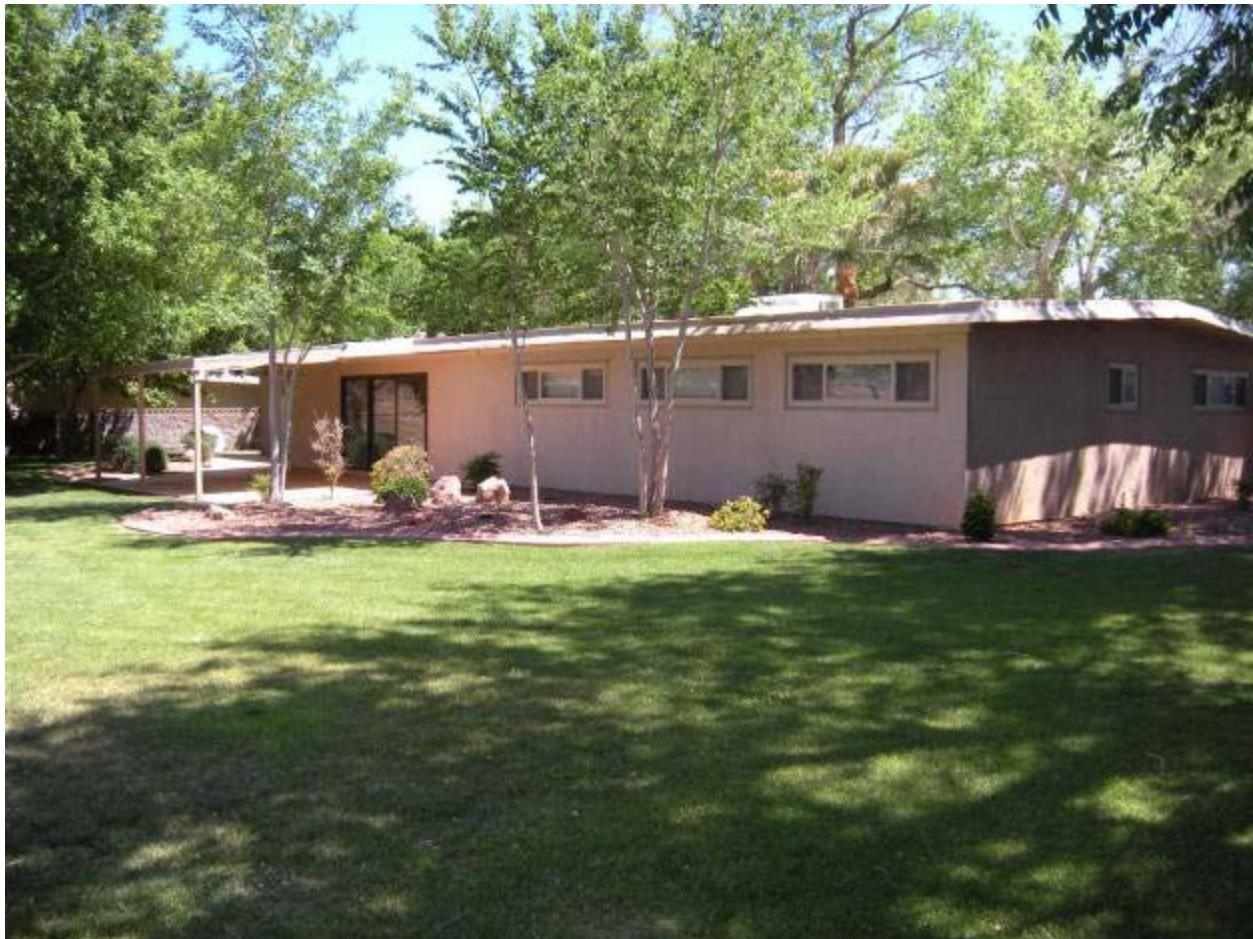
Figure 33, Parcel F, Building 644 rear view

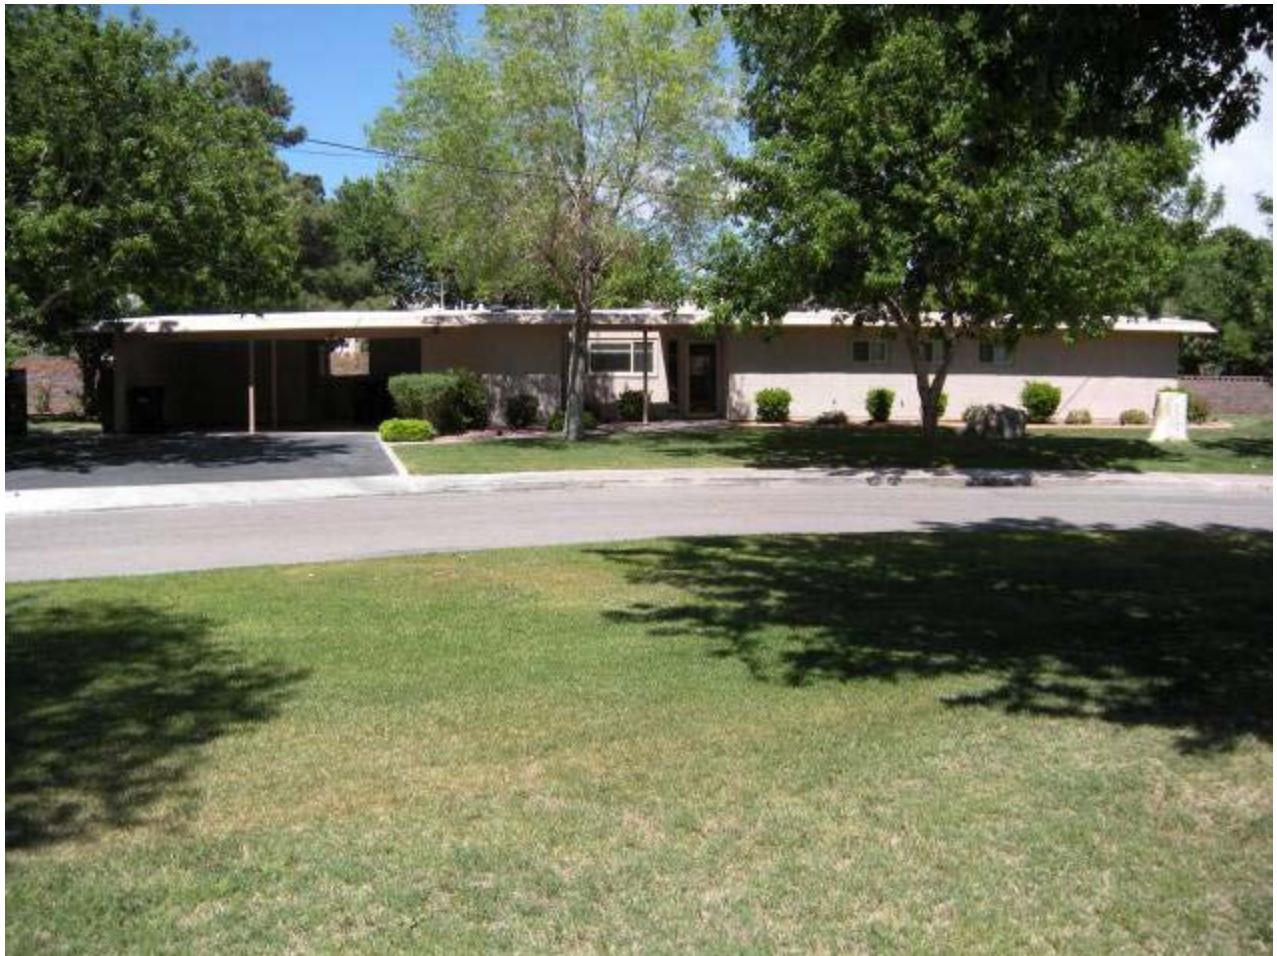
Figure 34, Parcel F, Building 645 front view

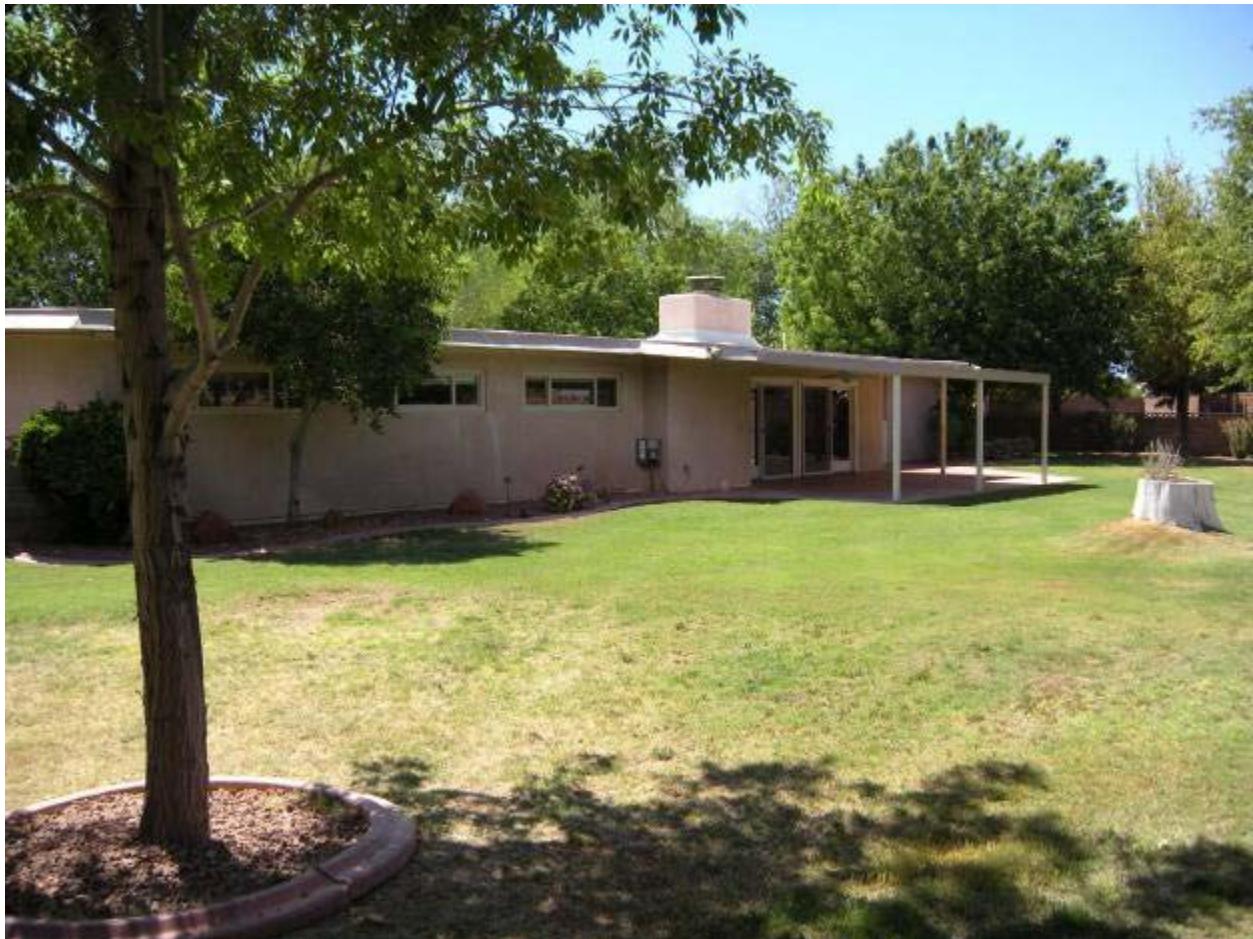
Figure 35, Parcel F, Building 645 rear view

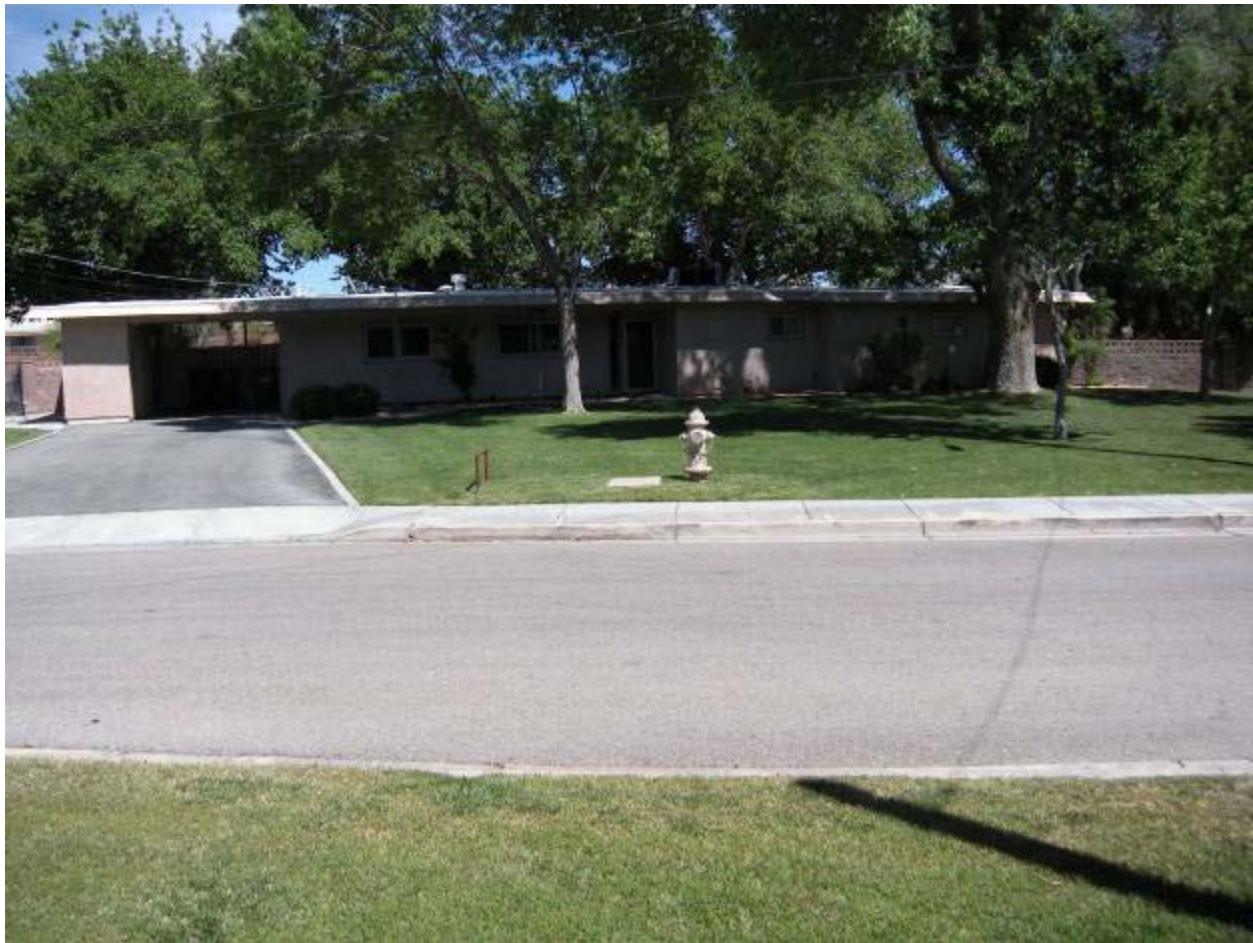
Figure 36, Parcel F, Building 646 front view

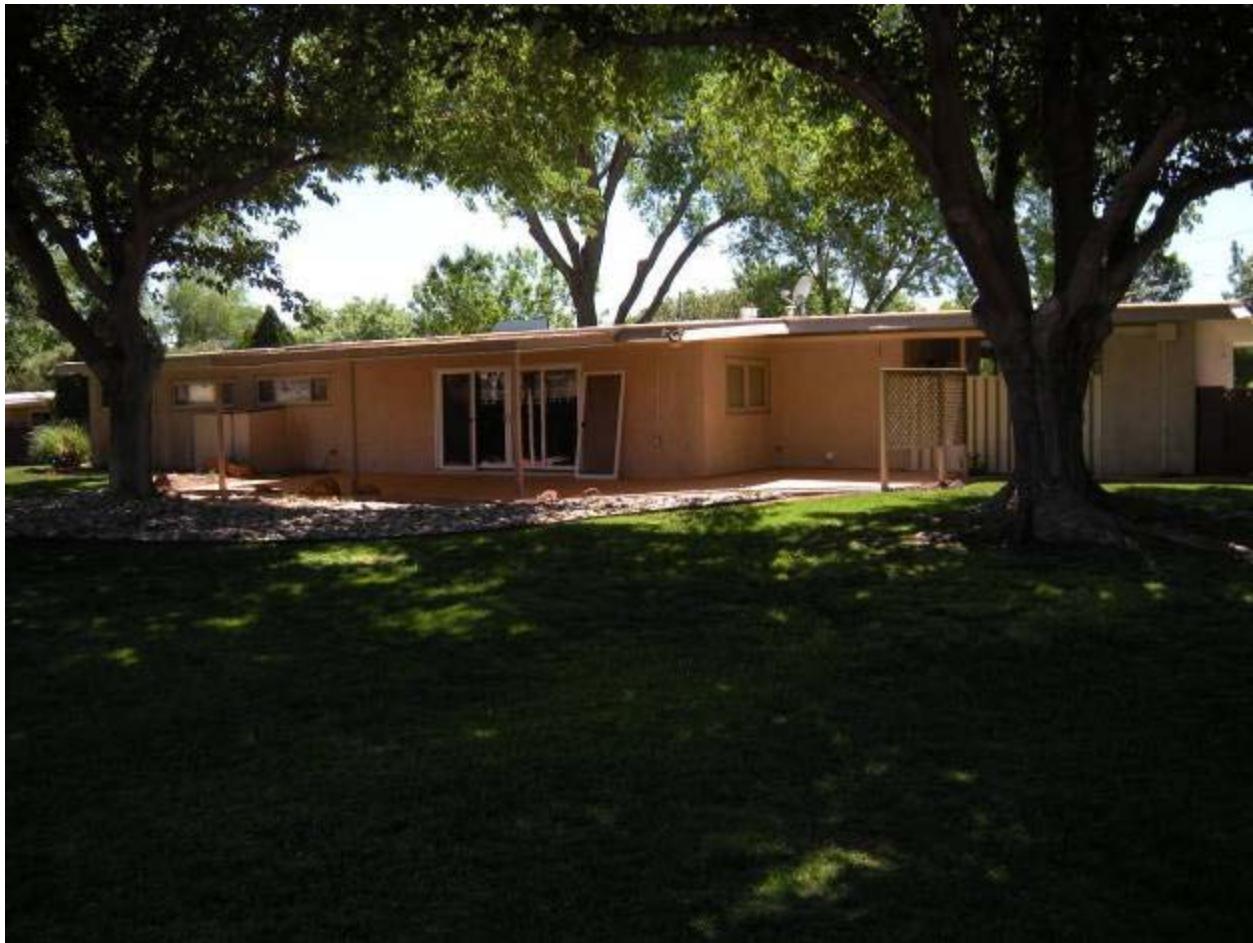
Figure 37, Parcel F, Building 646 rear view

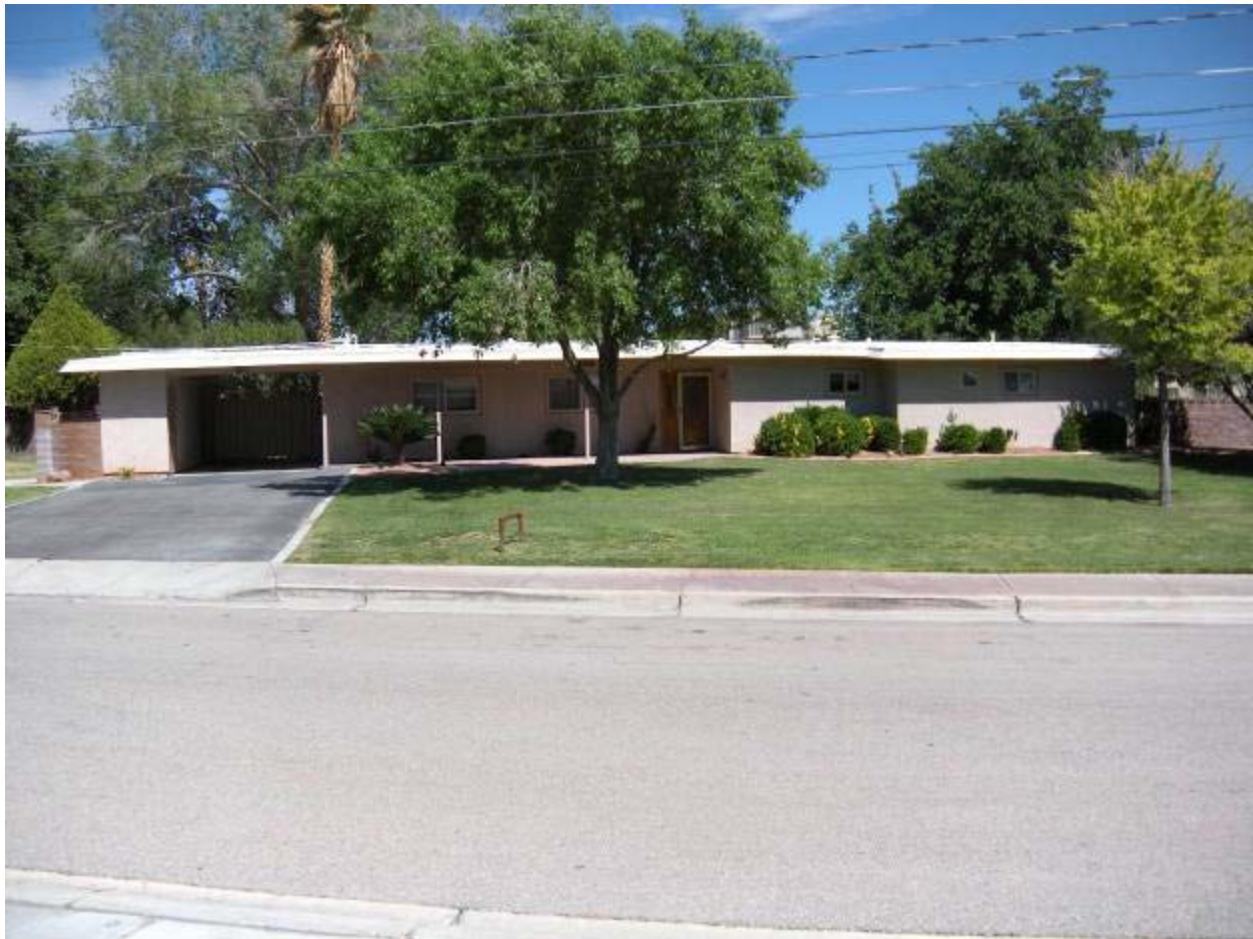
Figure 38, Parcel F, Building 647 front view

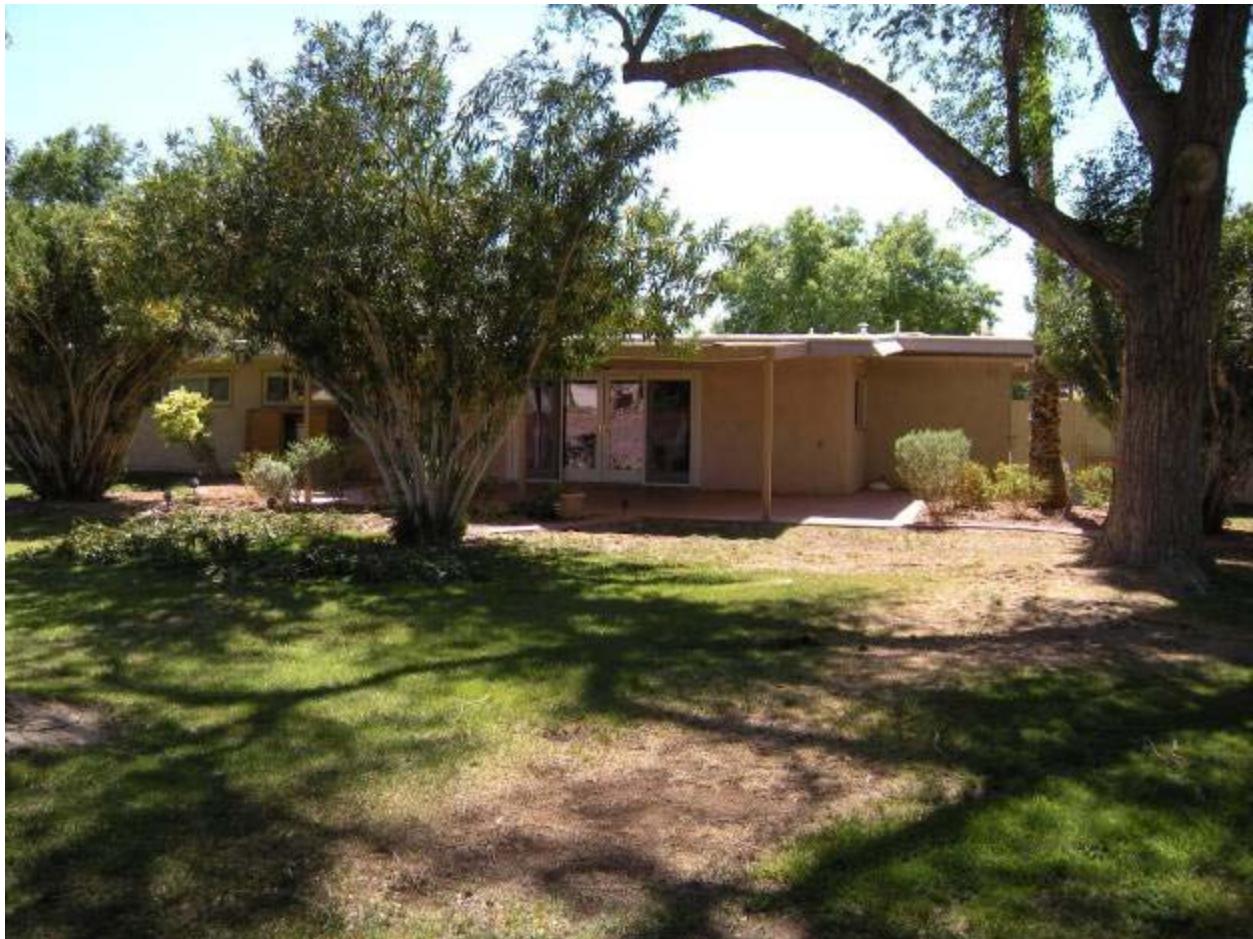
Figure 39, Parcel F, Building 647 rear view

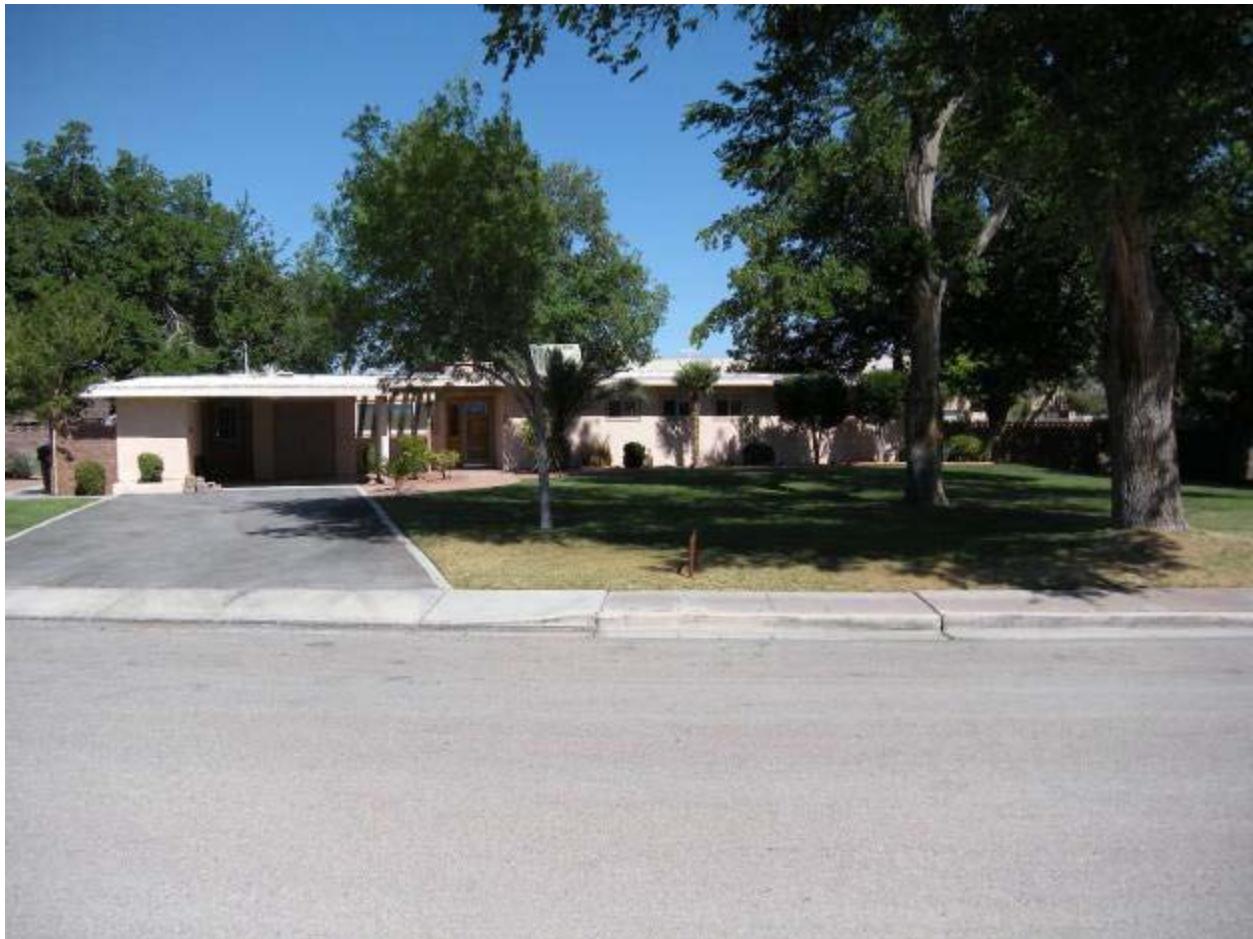
Figure 40, Parcel F, Building 648 front view

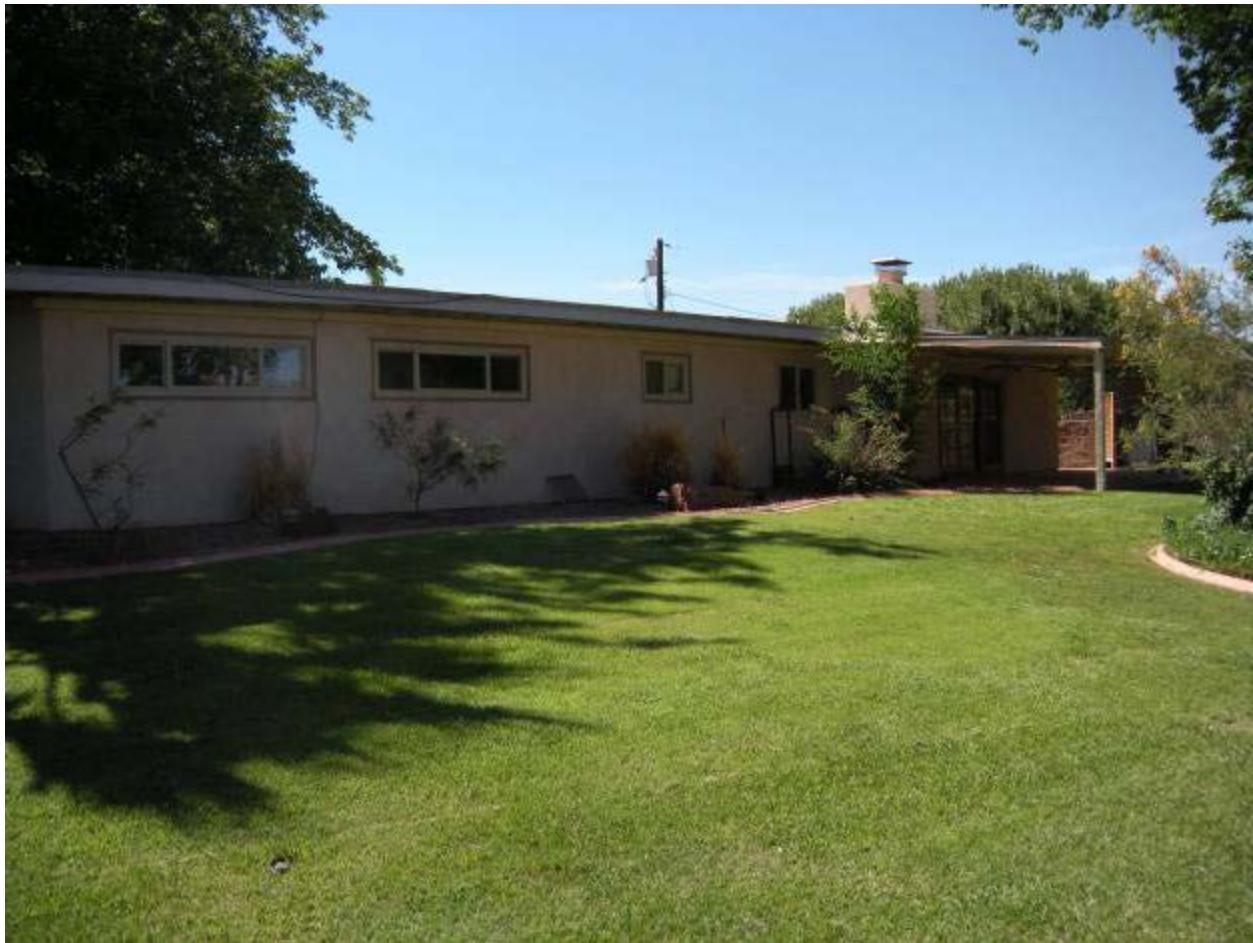
Figure 41, Parcel F, Building 648 rear view

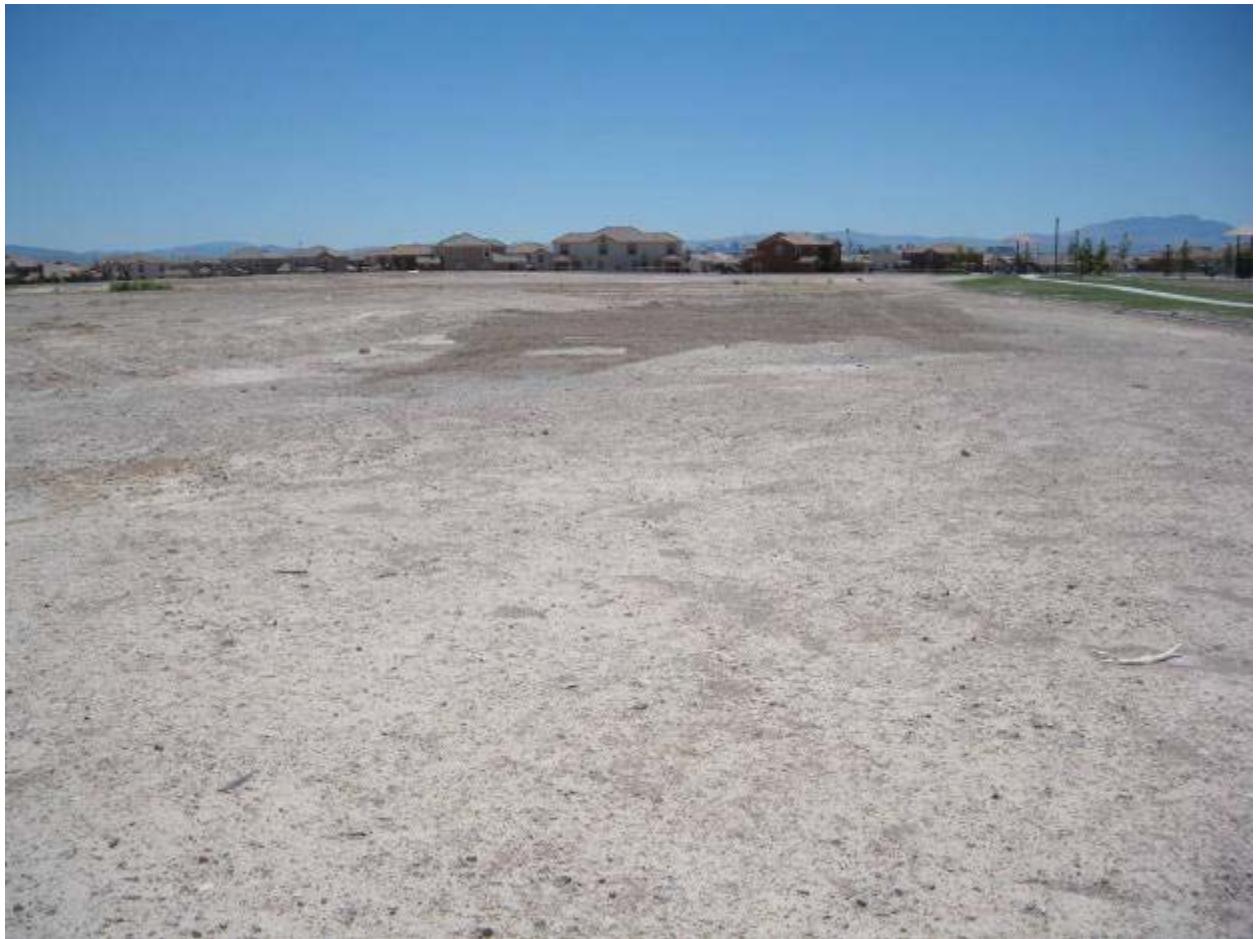
Figure 42, Parcel I looking south from north corner of parcel

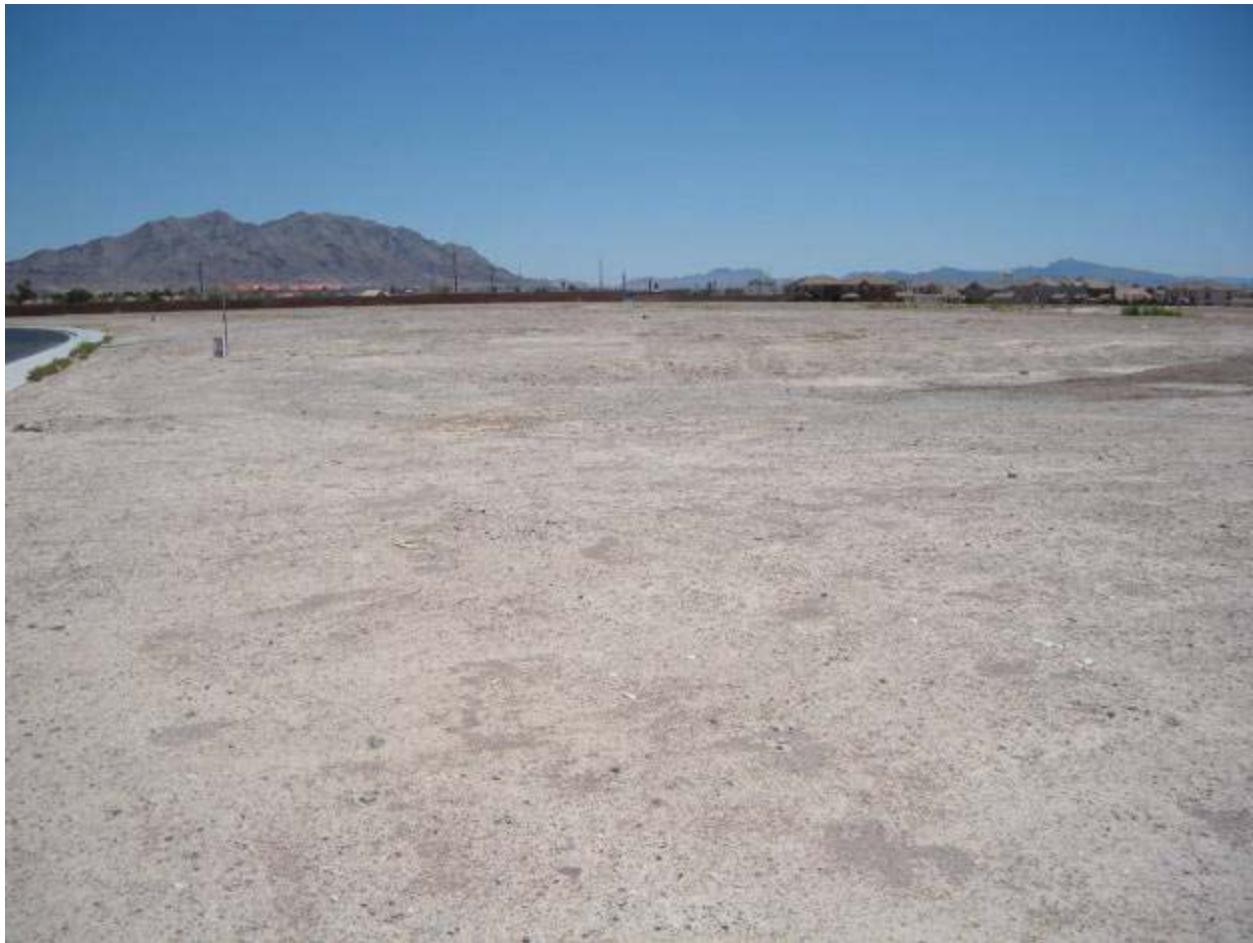
Figure 43, Parcel I looking east from north corner of parcel

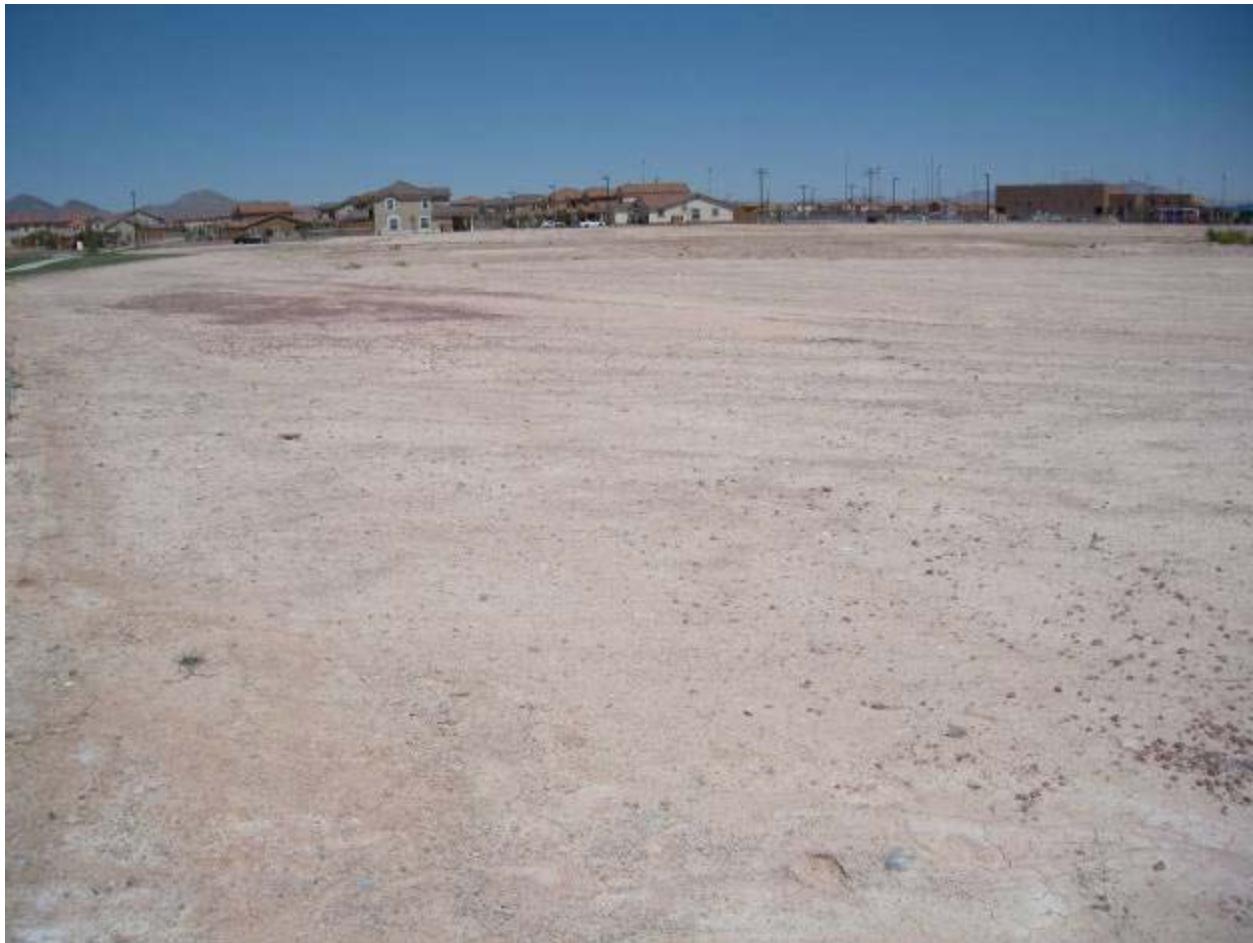
Figure 44, Parcel I looking north from south corner of parcel

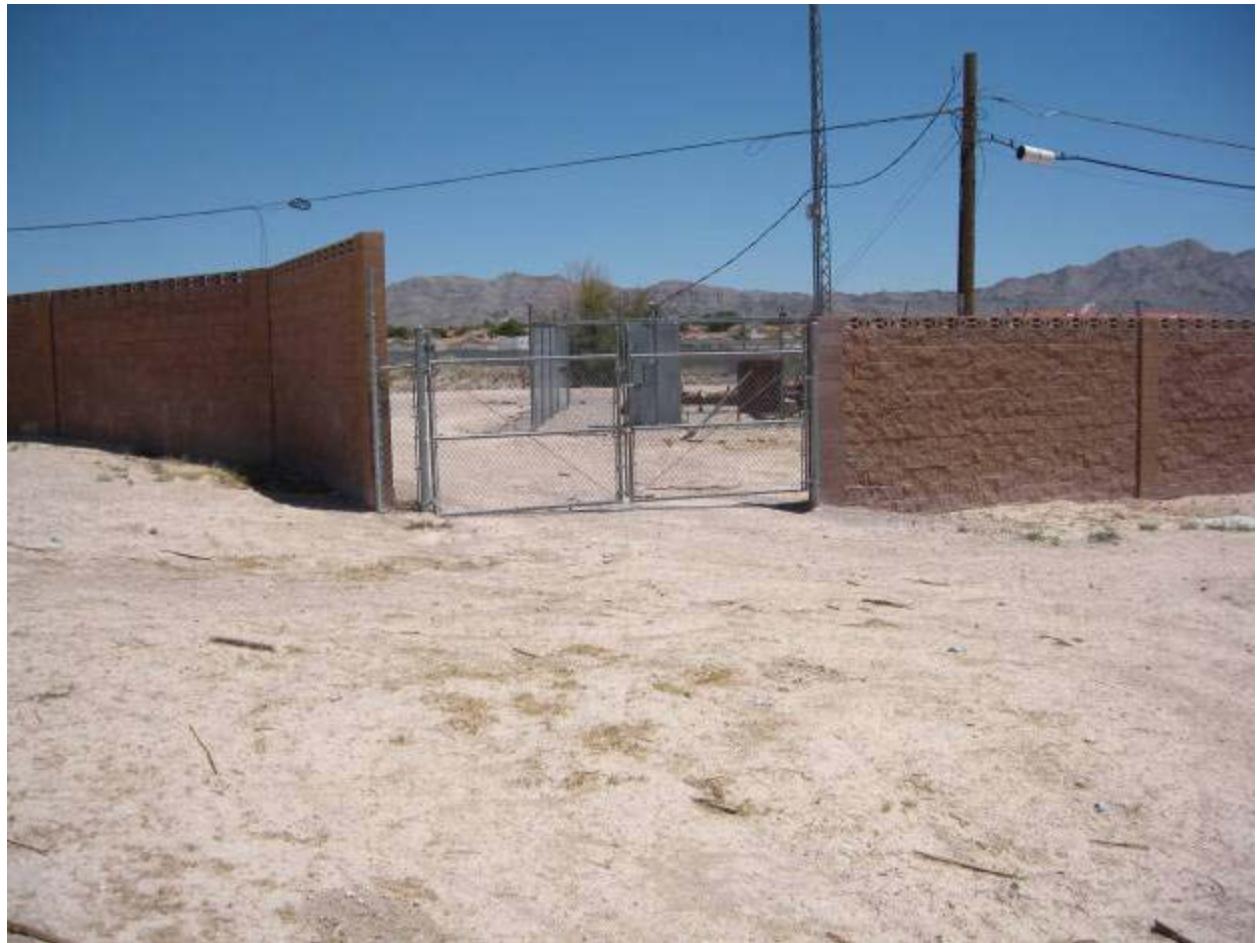
Figure 45, Parcel I gate located in eastern boundary wall

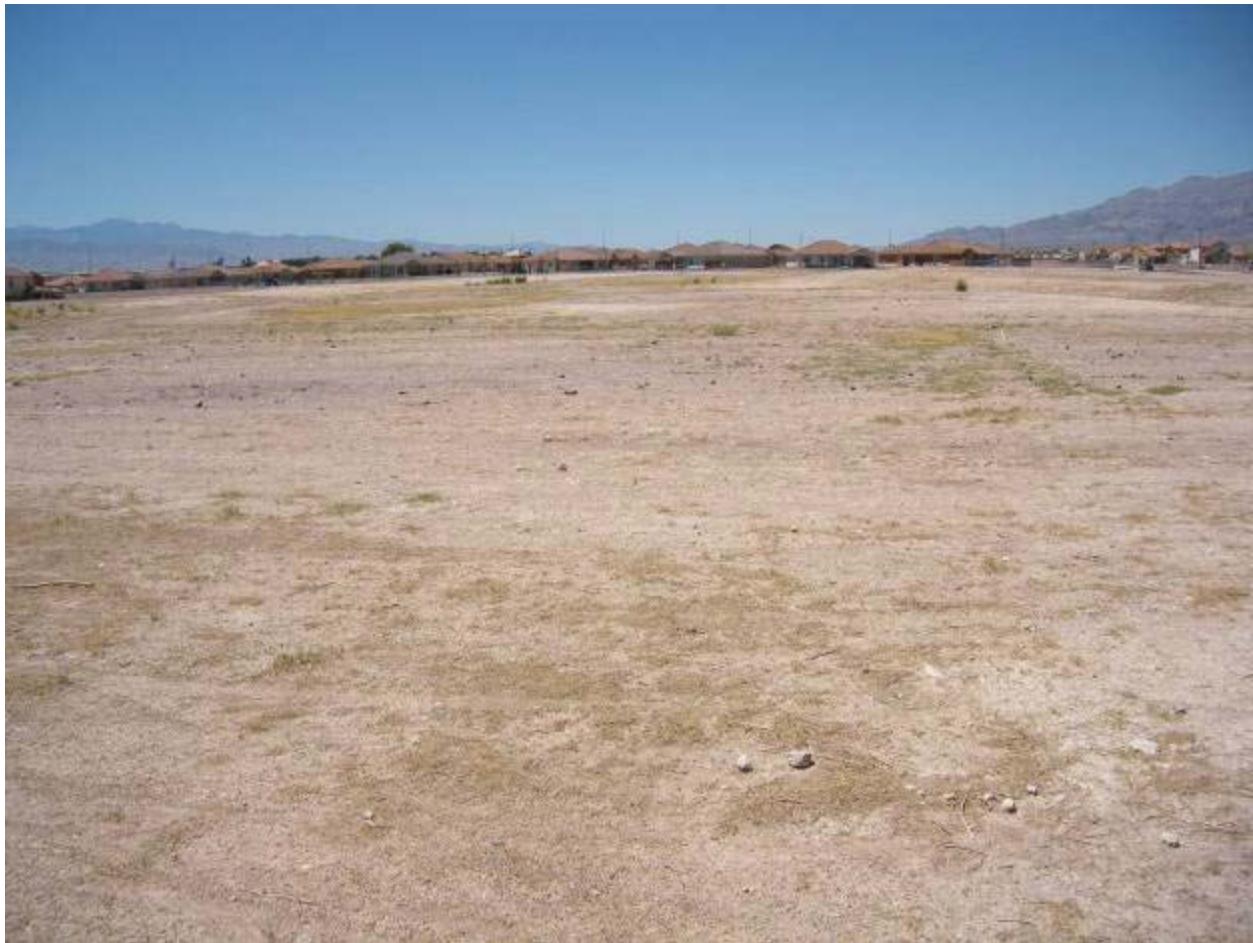
Figure 46, Parcel I looking west from east wall
